# Walk Around

## Focke-Wulf Fw 190A/F

Walk Around Number 22  
squadron/signal publications

By Malcolm Laing and E. Brown Ryle

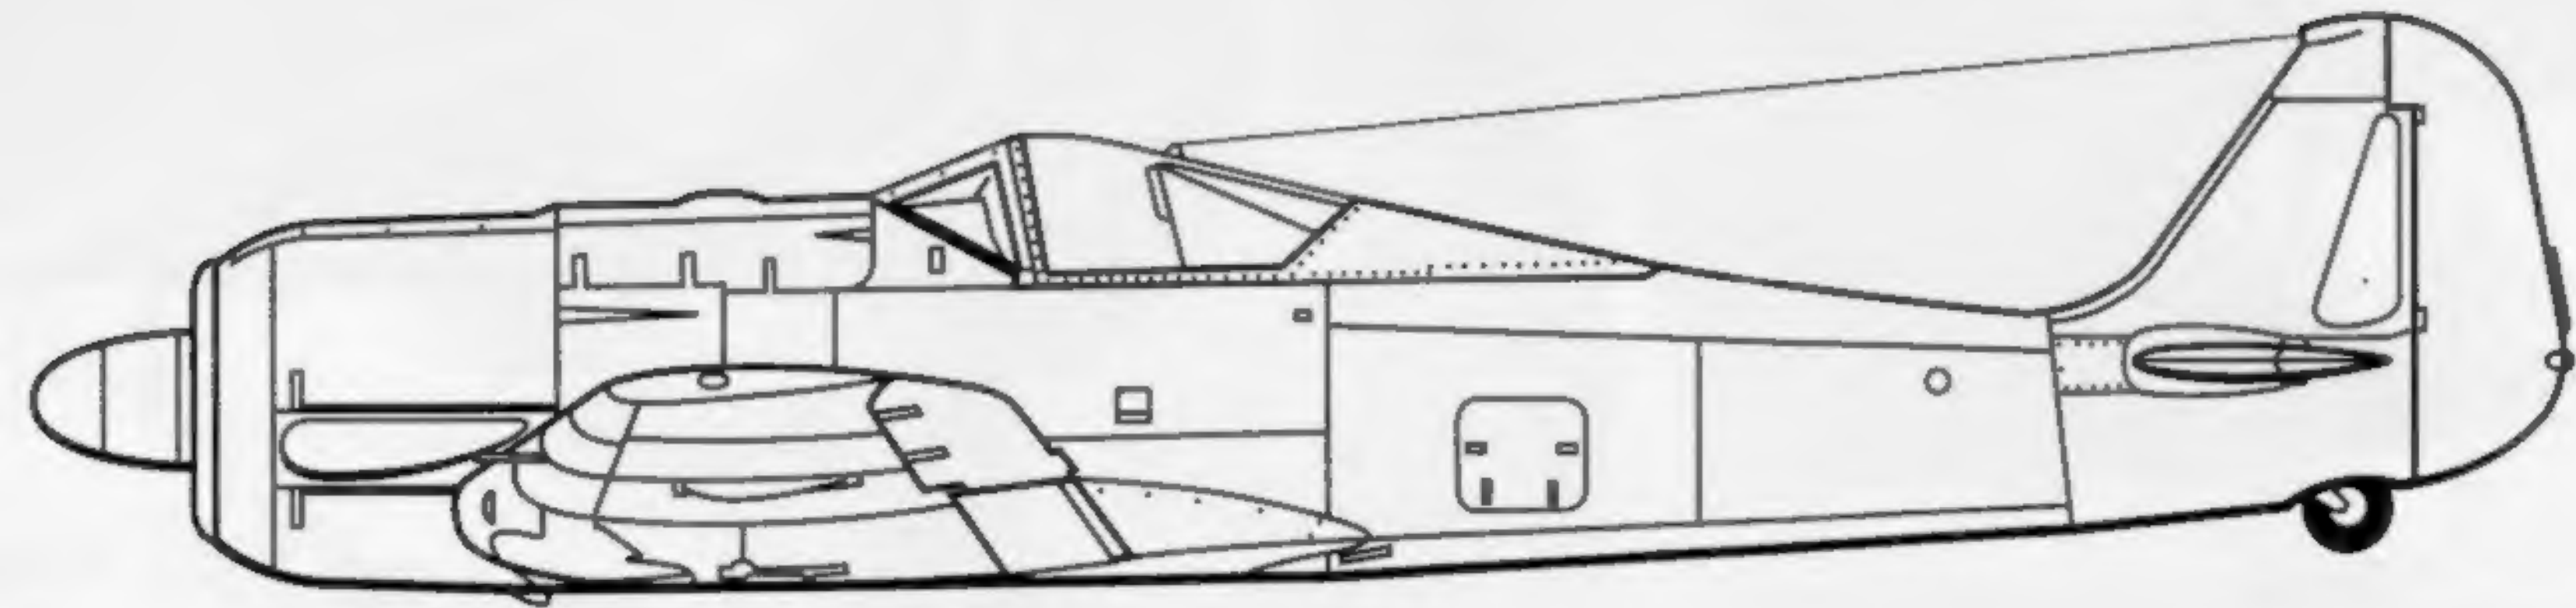
## **Fw 190A-1**

The first production series Fw 190 entered field evaluation during the spring of 1941. After a number of modifications were made as a result of field trials, full-scale production began in the summer of 1941. The Fw 190A-1 entered service with II *Gruppe*/JG 26, where they prevailed in its first combat with opposing fighters – RAF Spitfire Mk. Vs – on 1 September 1941. The aircraft was armed with four 7.92mm MG17 machine guns and two 20mm MG FF cannon.

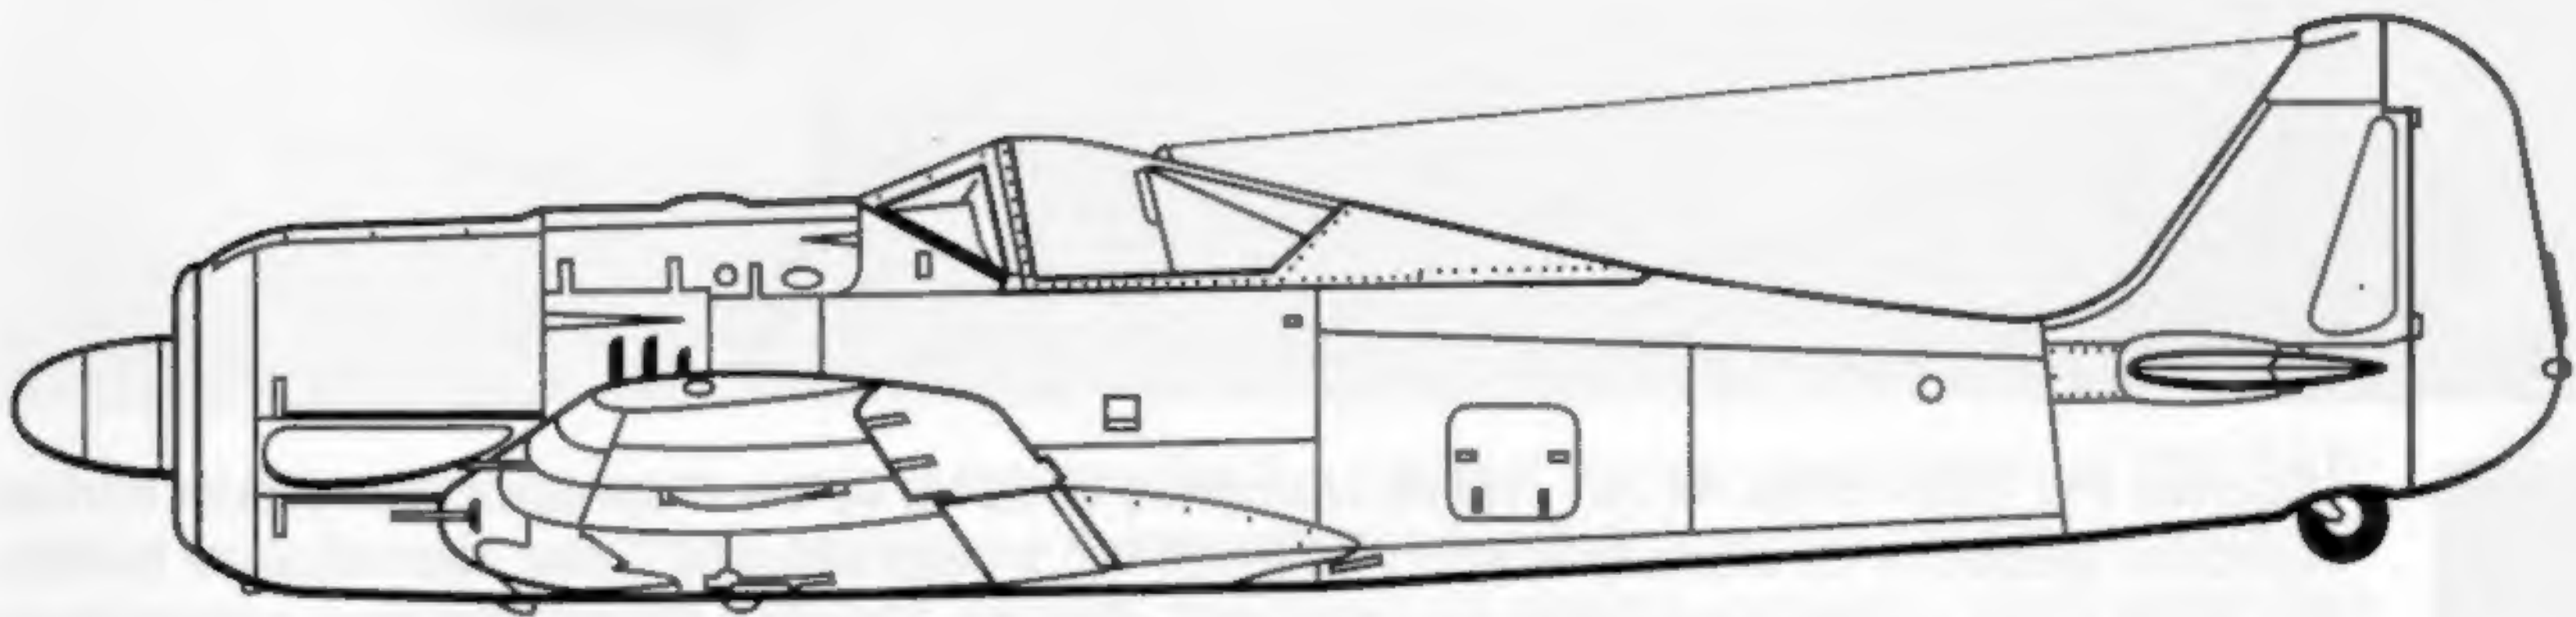
## **Fw 190A-3**

The A-3 standardized on the A-2's equipment, including the BMW 801D engine and the armament, although the two wing-mounted 20mm MG FF cannon were often removed to reduce weight and increase speed. An ETC 501 rack could be mounted on the fuselage underside to carry a 79.3 gallon (300 L) drop tank or a 551.1 lb (250 kg) or 1102.3 lb (500 kg) bomb. The Fw 190A-3 entered squadron service by the spring of 1942, serving alongside the A-2s and allowing withdrawal of the A-1s from frontline use.

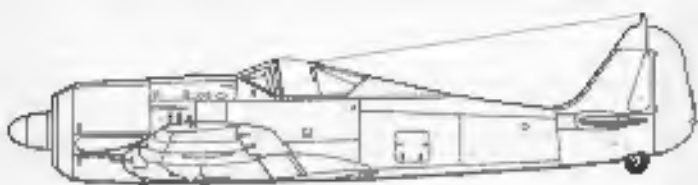
### **Fw 190A-4**

The A-4 retained the A-3's basic structure; however, the newer version's FuG 15 radio resulted in the addition of a ventral antenna mast on top of the A-4's vertical stabilizer. A variety of factory and field conversion units allowed the Fw 190A-4 to become a multi-role aircraft, capable of fighter-bomber, ground attack, photo reconnaissance, and bomber destroyer roles. The first A-4s were delivered in June of 1942 and production continued until early 1943.

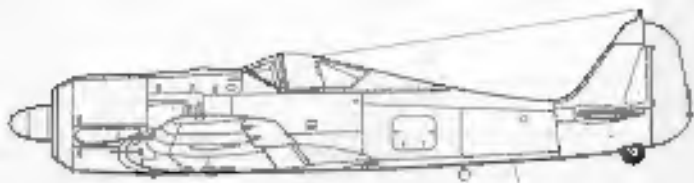
## Fw 190A-5

The A-5 engine and cowling were extended six inches (152.4 mm) forward to improve the aircraft's center of gravity and reduce vibration over the A-4. Adjustable fuselage engine cooling gills – introduced in late A-4s – became standard, along with solid main wheel hubs. Two ETC 500 wing racks could be installed to carry four 113.2 lb (50 kg) bombs. A number of conversion sets allowed Fw 190A-5s to undertake a variety of missions. The A-5 was superseded on the production line by the Fw 190A-6 in late 1943.

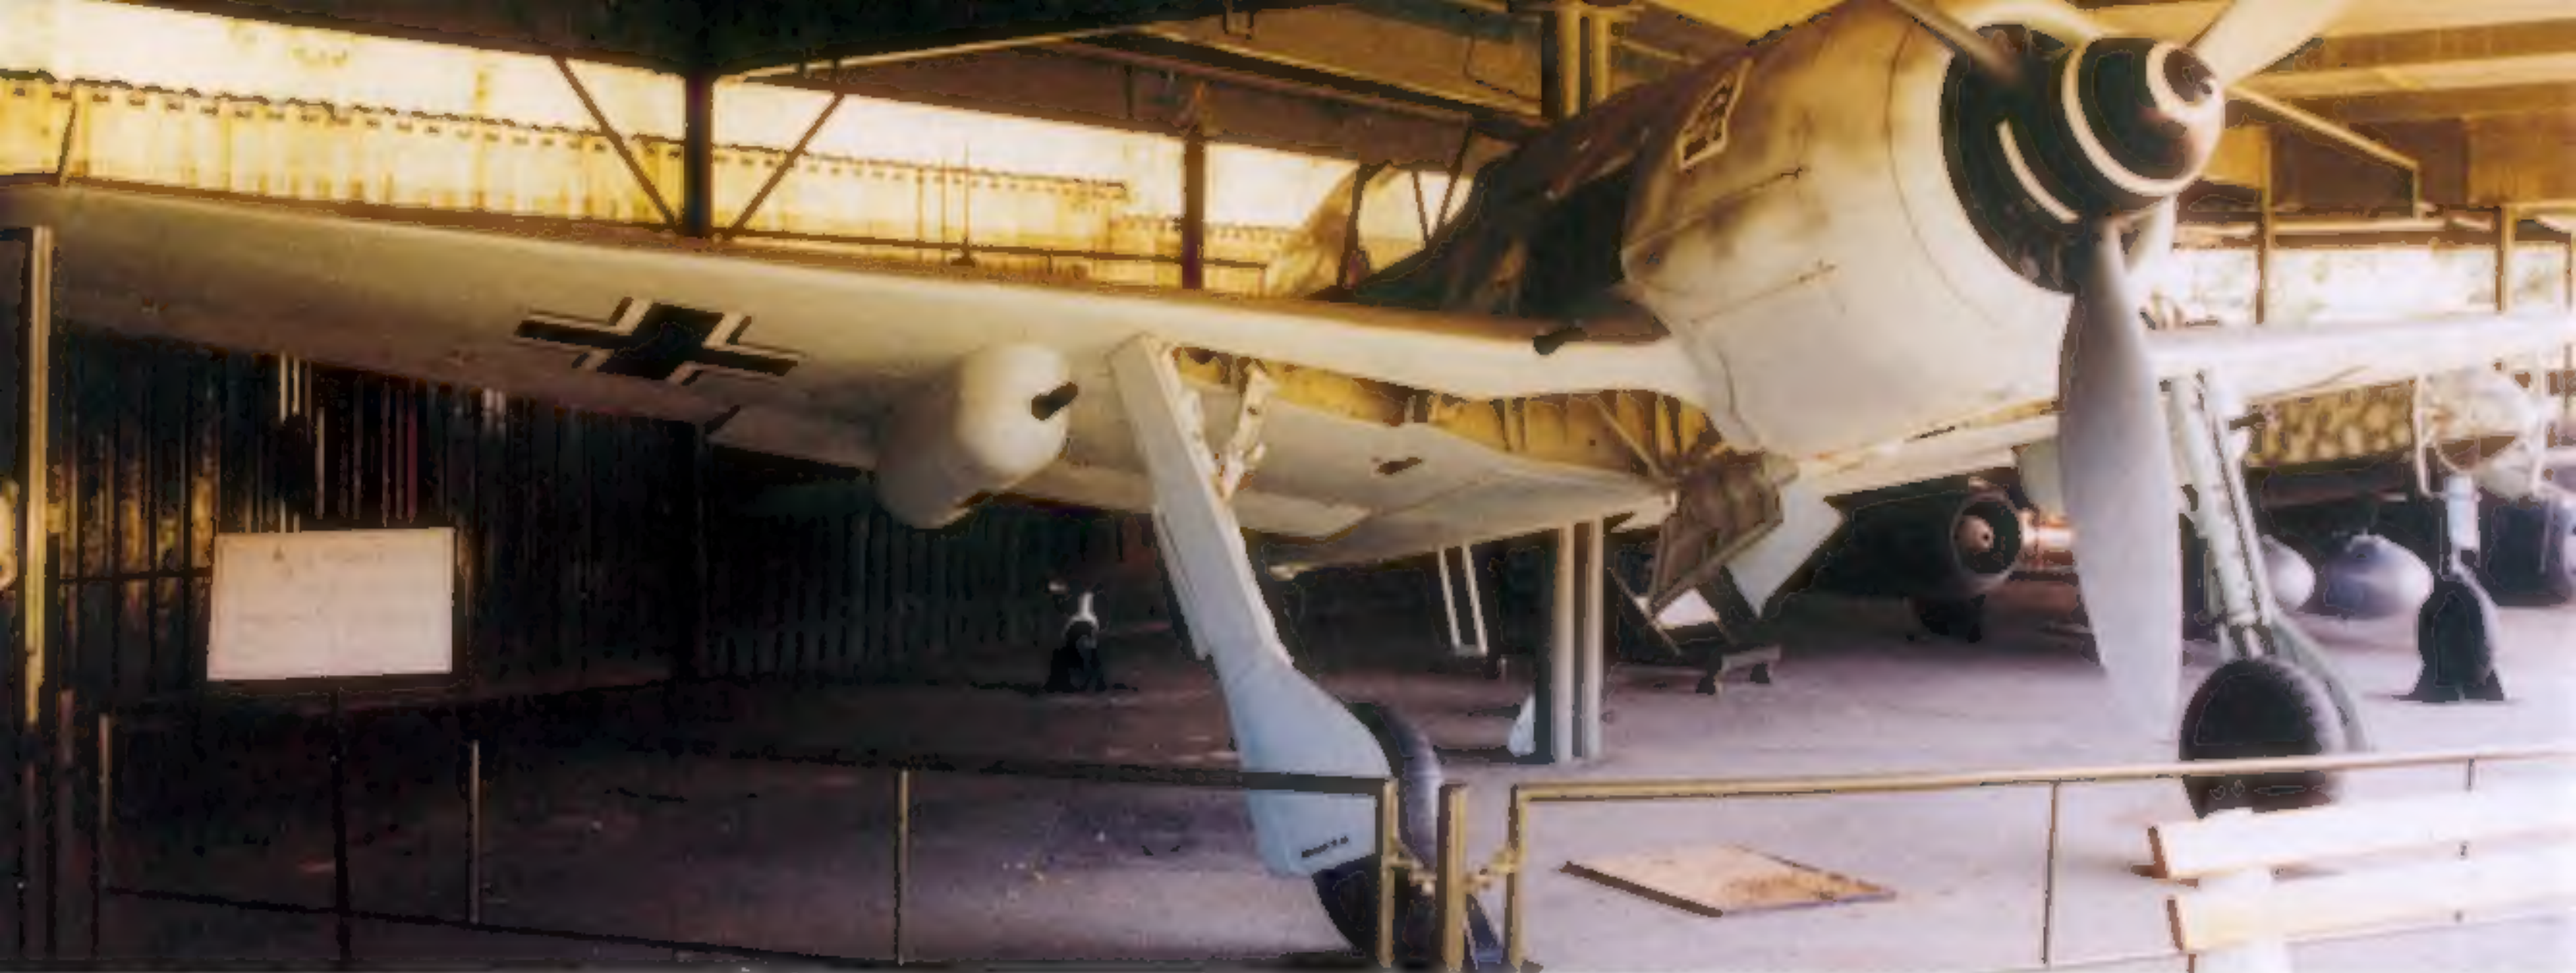
(Above) Fw 190A-6/R8, W.Nr. (Werk Nummer) 550214, is on display at the South African National Museum of Military History (SANMMH) in Saxonwold. This aircraft was built by the AGO plant in Obersleben in May or June of 1943. This Fw 190A-6/R8 was a night fighter equipped with a FuG (Funk Geräte; Radio Device) 217 *Neptun* (Neptune) J-2 radar. The fighter was coded PN+LU and was believed to have been used for testing with either the 7th or 8th *Staffel* of III/NJG 11, a night fighter unit primarily using Messerschmitt Bf 109s. This aircraft was surrendered at Leck, Germany and flown from Scheswig, Germany to

Farnborough, England on 16 June 1945. The Fw 190A-6 was later displayed as a war trophy in Hyde Park, London, then stored and eventually shipped to Cape Town, South Africa aboard the SS PERTHSHIRE in October of 1946. The fighter was stored at the South African Air Force Central Flying School at Dunnottar from 1946 to 1971, then sent to No.15 Air Depot at Snake Valley and eventually transferred to the SANMMH in 1972. A restoration of this Fw 190A-6 was conducted from 1989 to 1990. The 30mm gun pods under the wings are reproductions. (Molnar & Hugo)

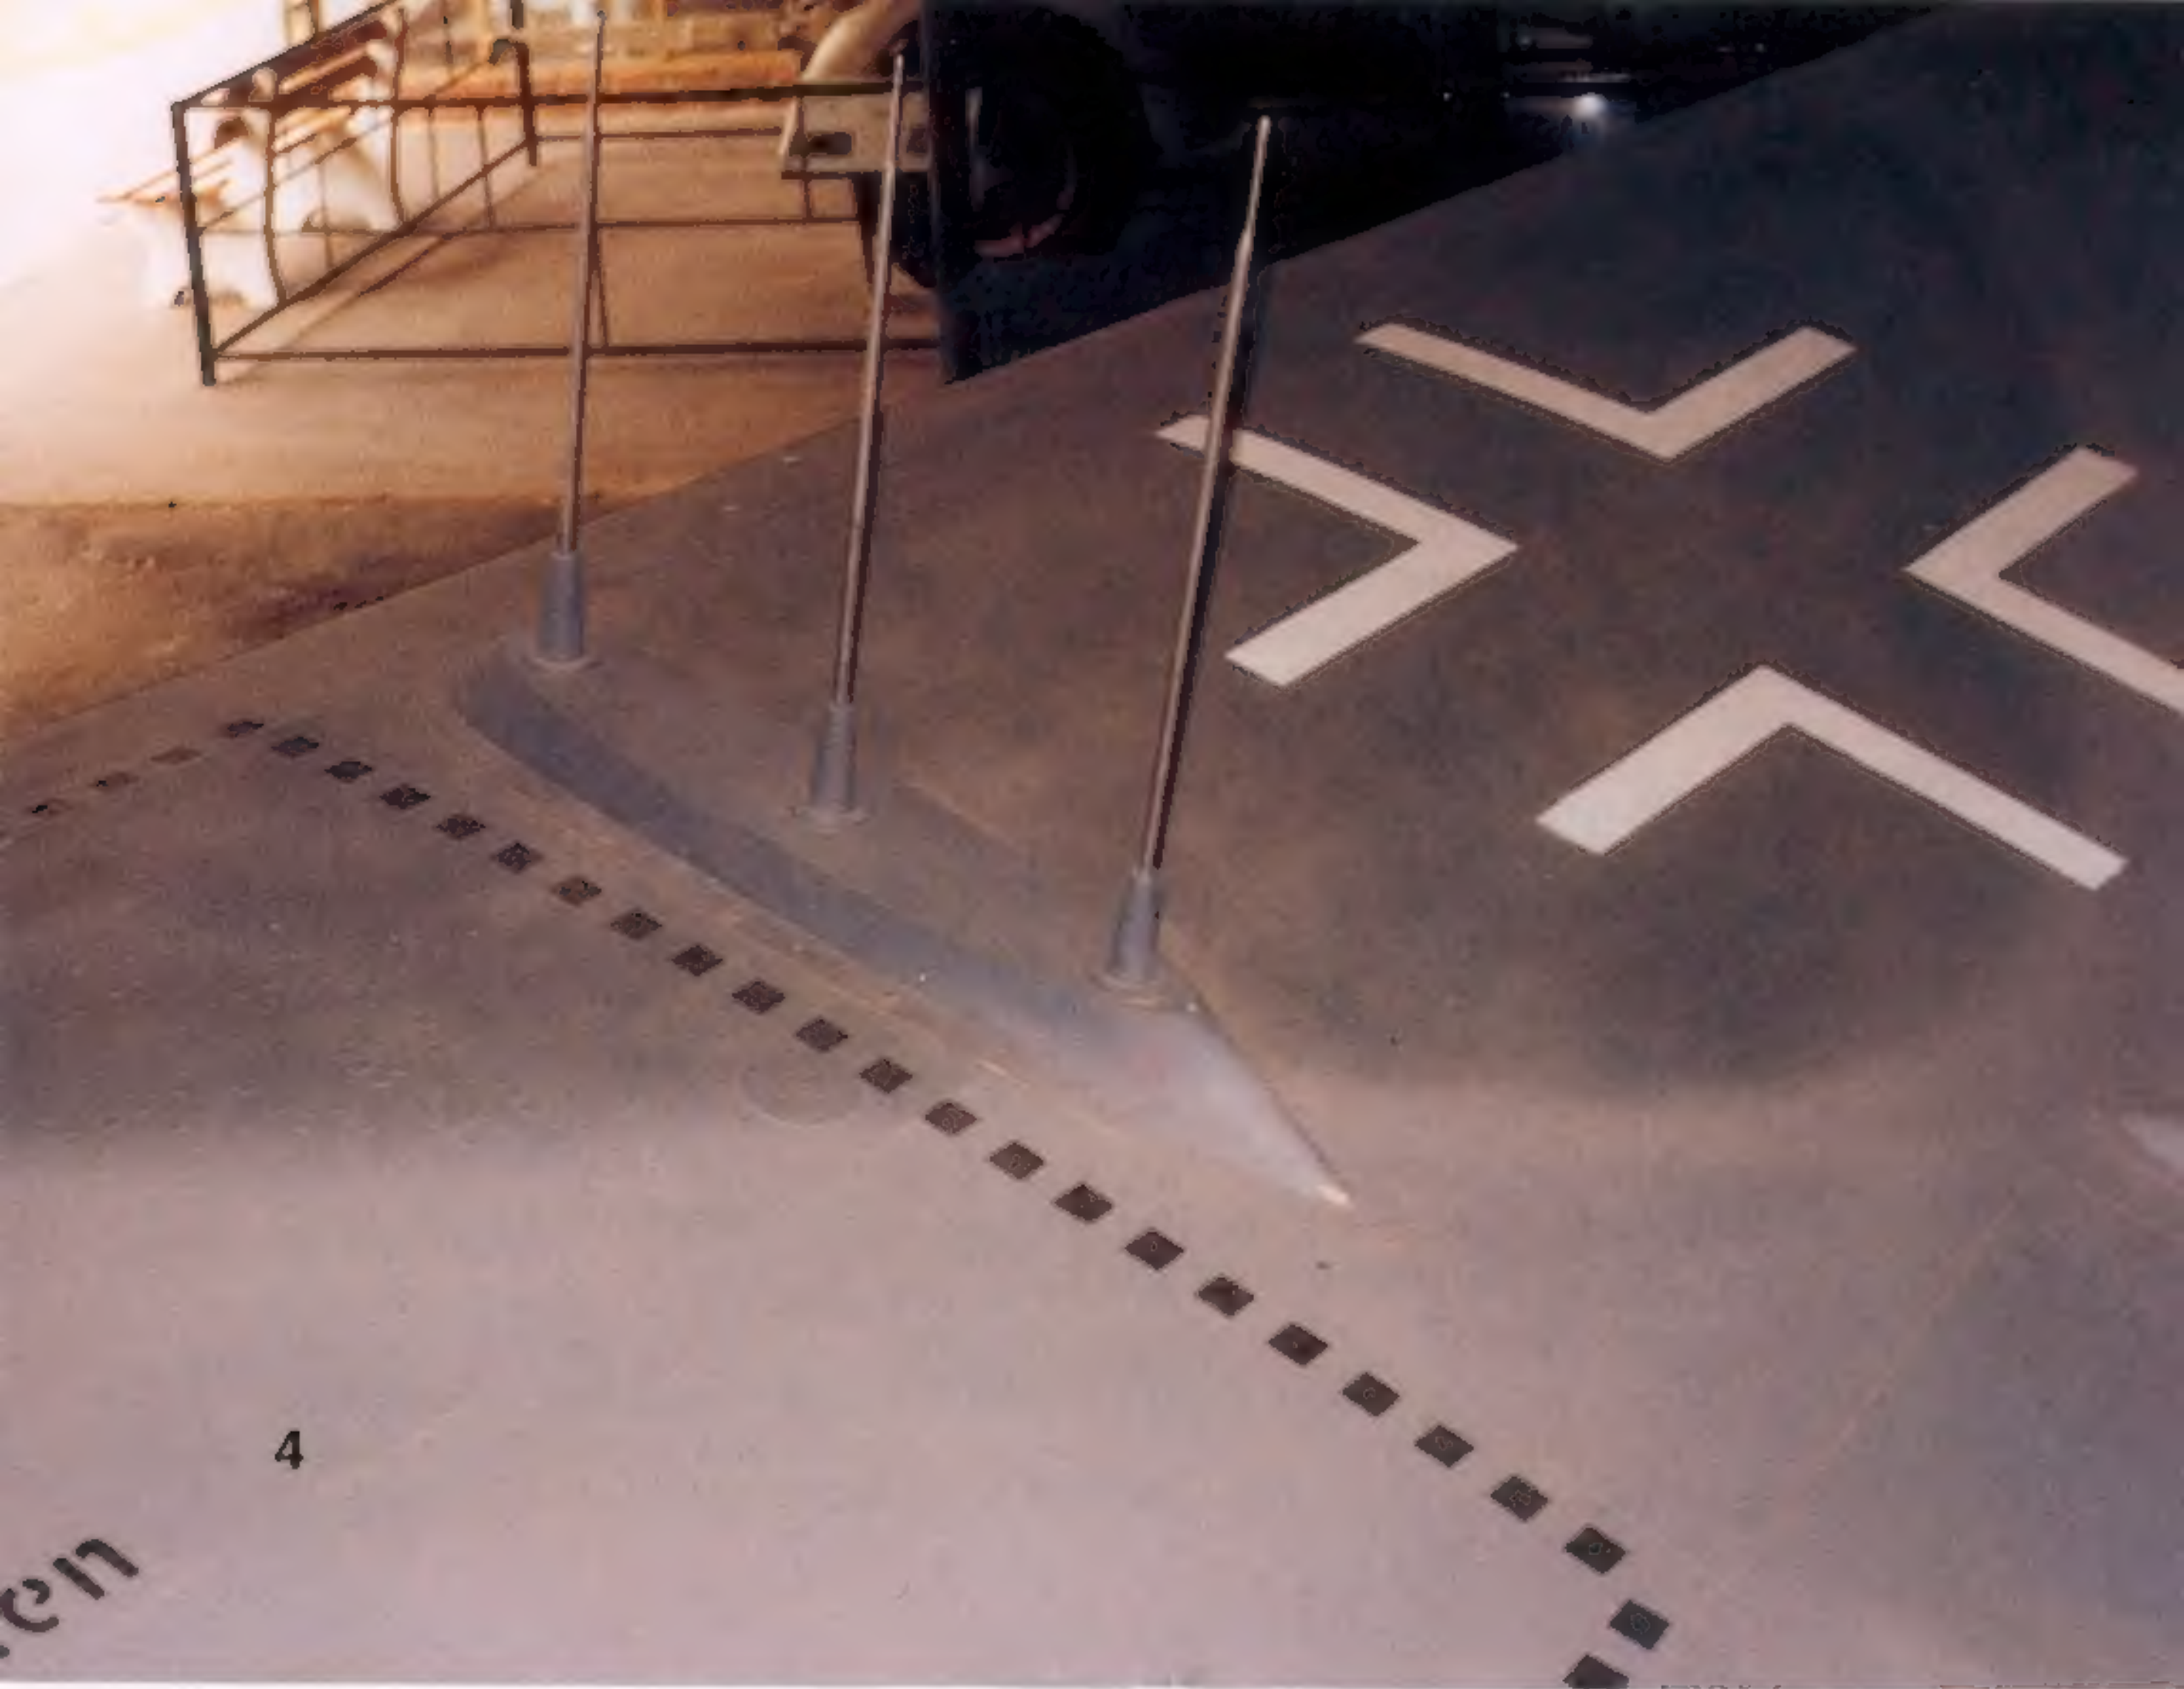
(Left) A replica FuG 217 *Neptun* radar antenna mount is installed on the upper starboard wing of the Fw 190A-6 experimental night fighter. Another radar mount of this design is located in the same location on the aircraft's port wing. The wing is painted RLM 74 Gray-Green (FS34086) and RLM 75 Gray-Violet (FS36122), while the black dotted lines delineate the *Nur hier betreten* (step here only) area of the wing. (Molnar & Hugo)

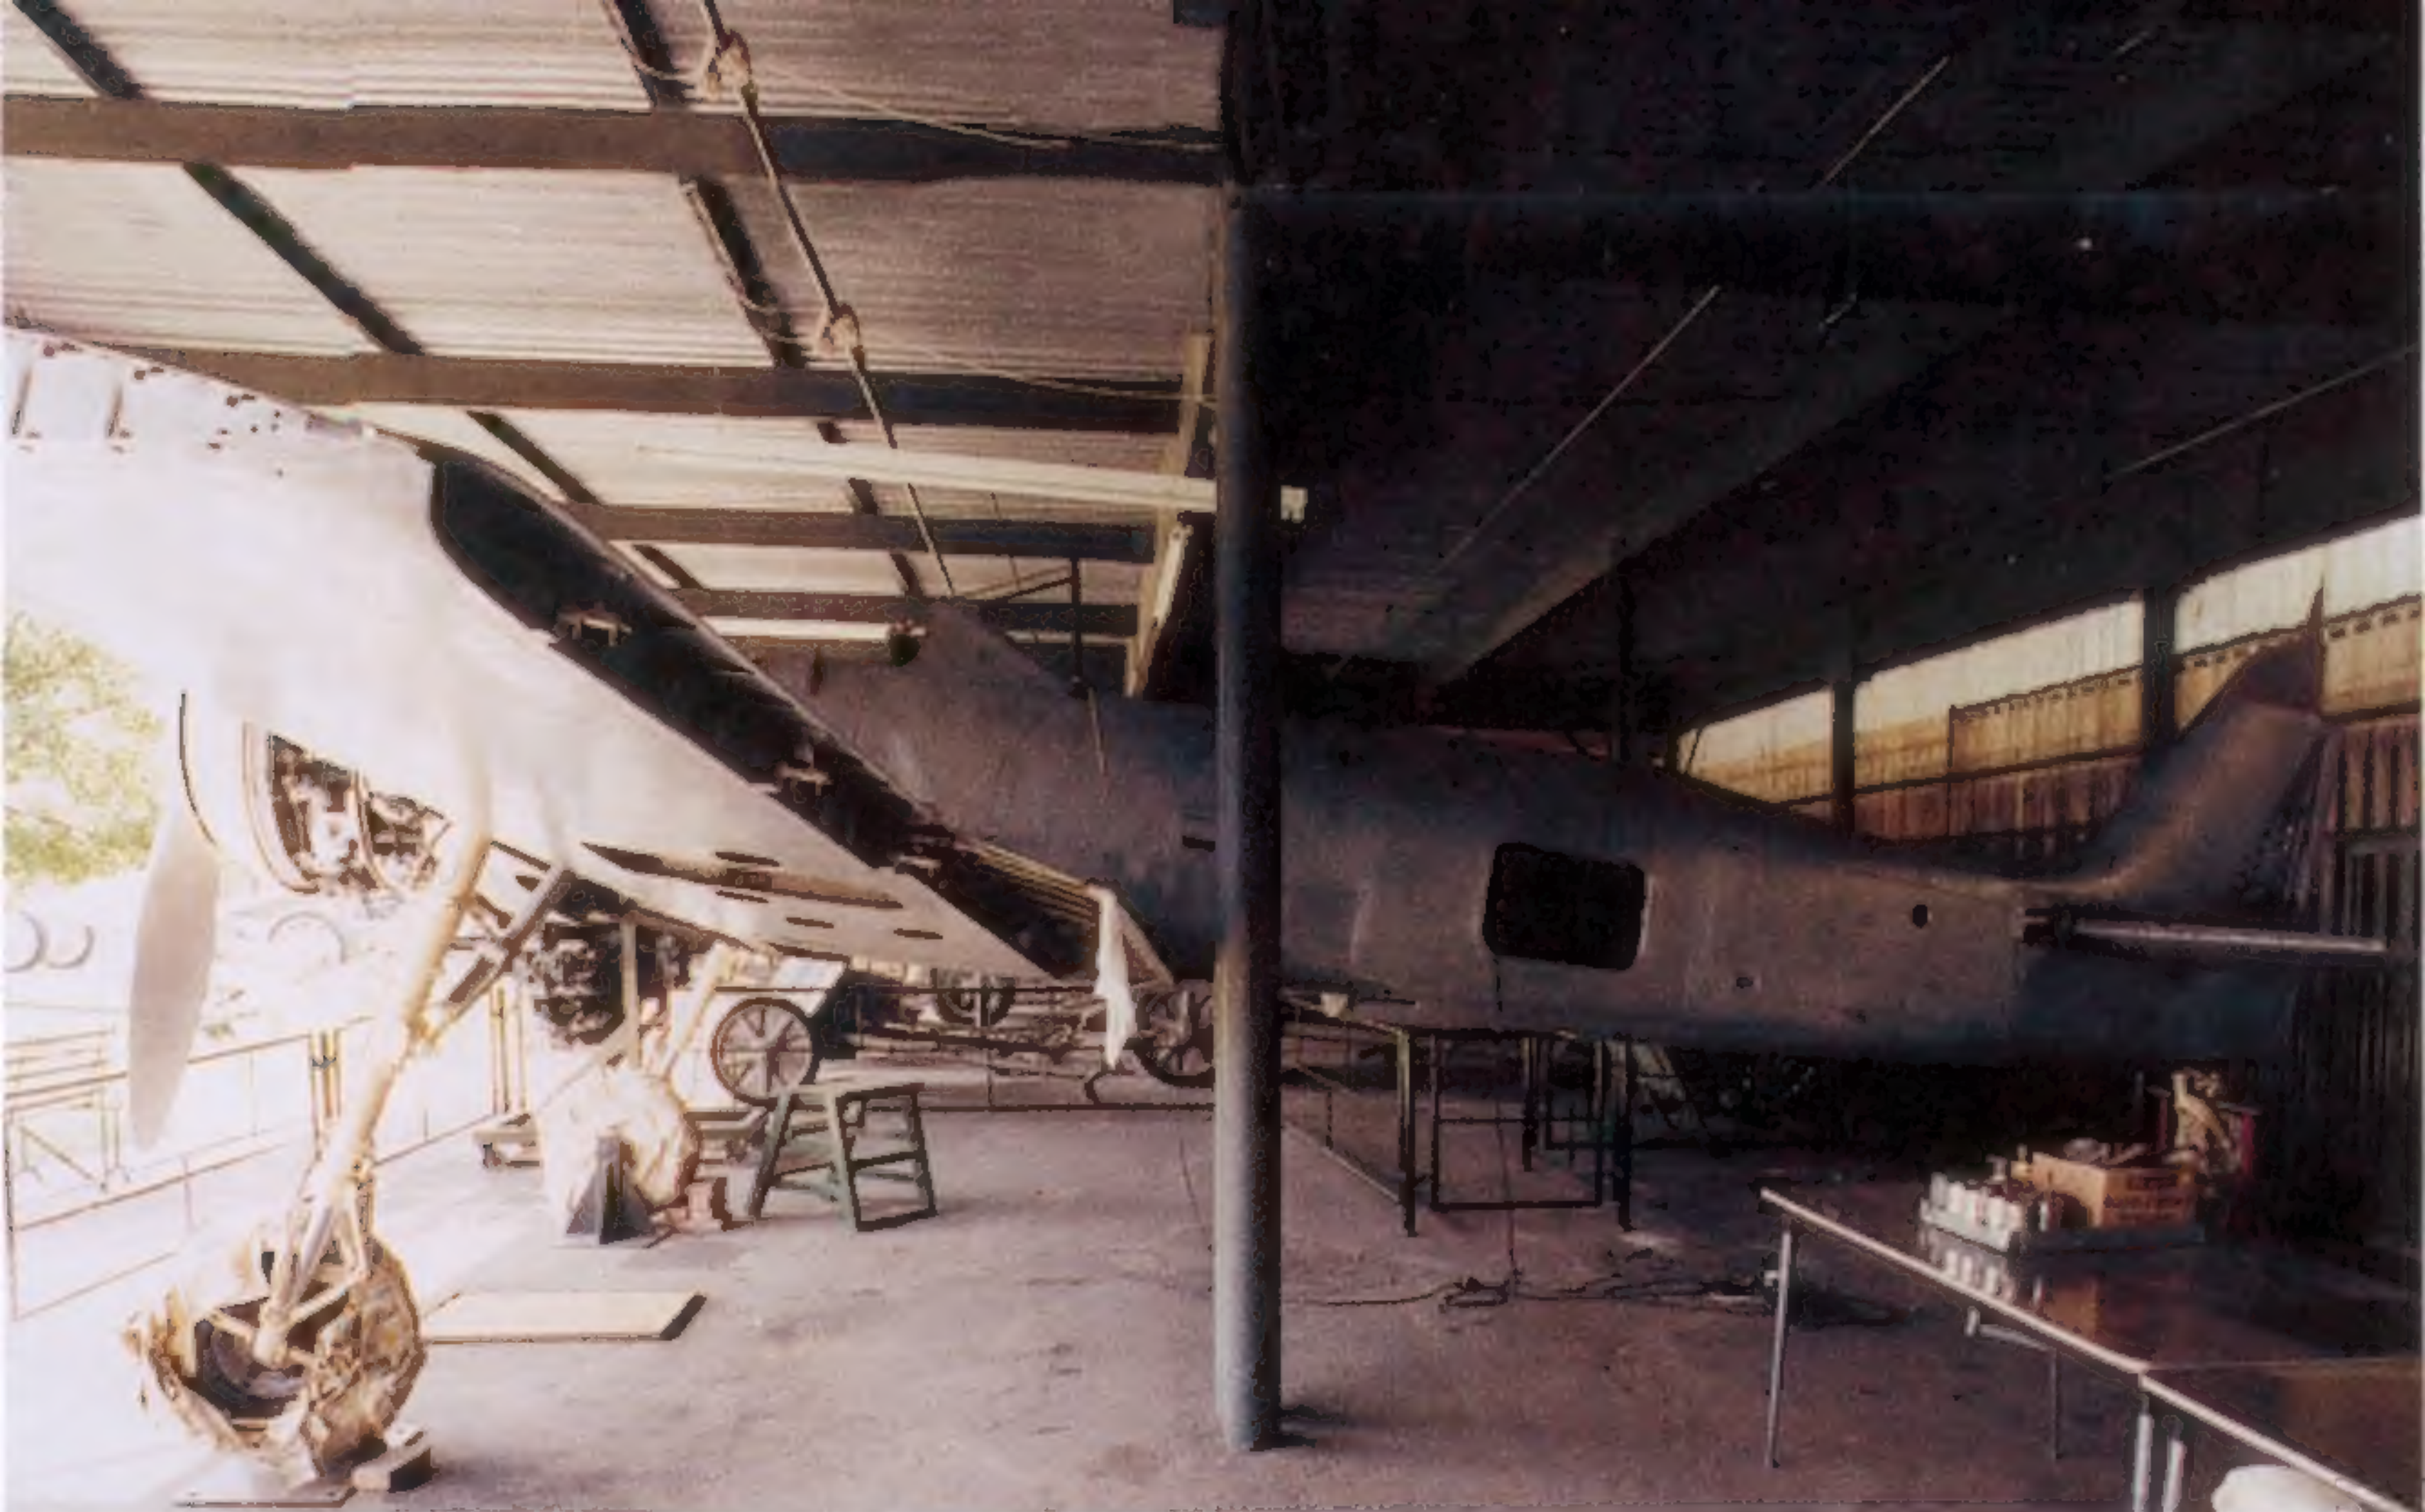
**(Above) All paint has been removed from the Fw 190A-6 during restoration at the SAN-MMH. The ailerons and flaps have been removed for refurbishing. The aircraft's outboard cannon bay access panel, spinner, engine and cowling panels, canopy, fuselage access door, and rudder have also been removed. The landing gear legs are being painted RLM 02 Gray (FS36165). (Laing via Rubin)**

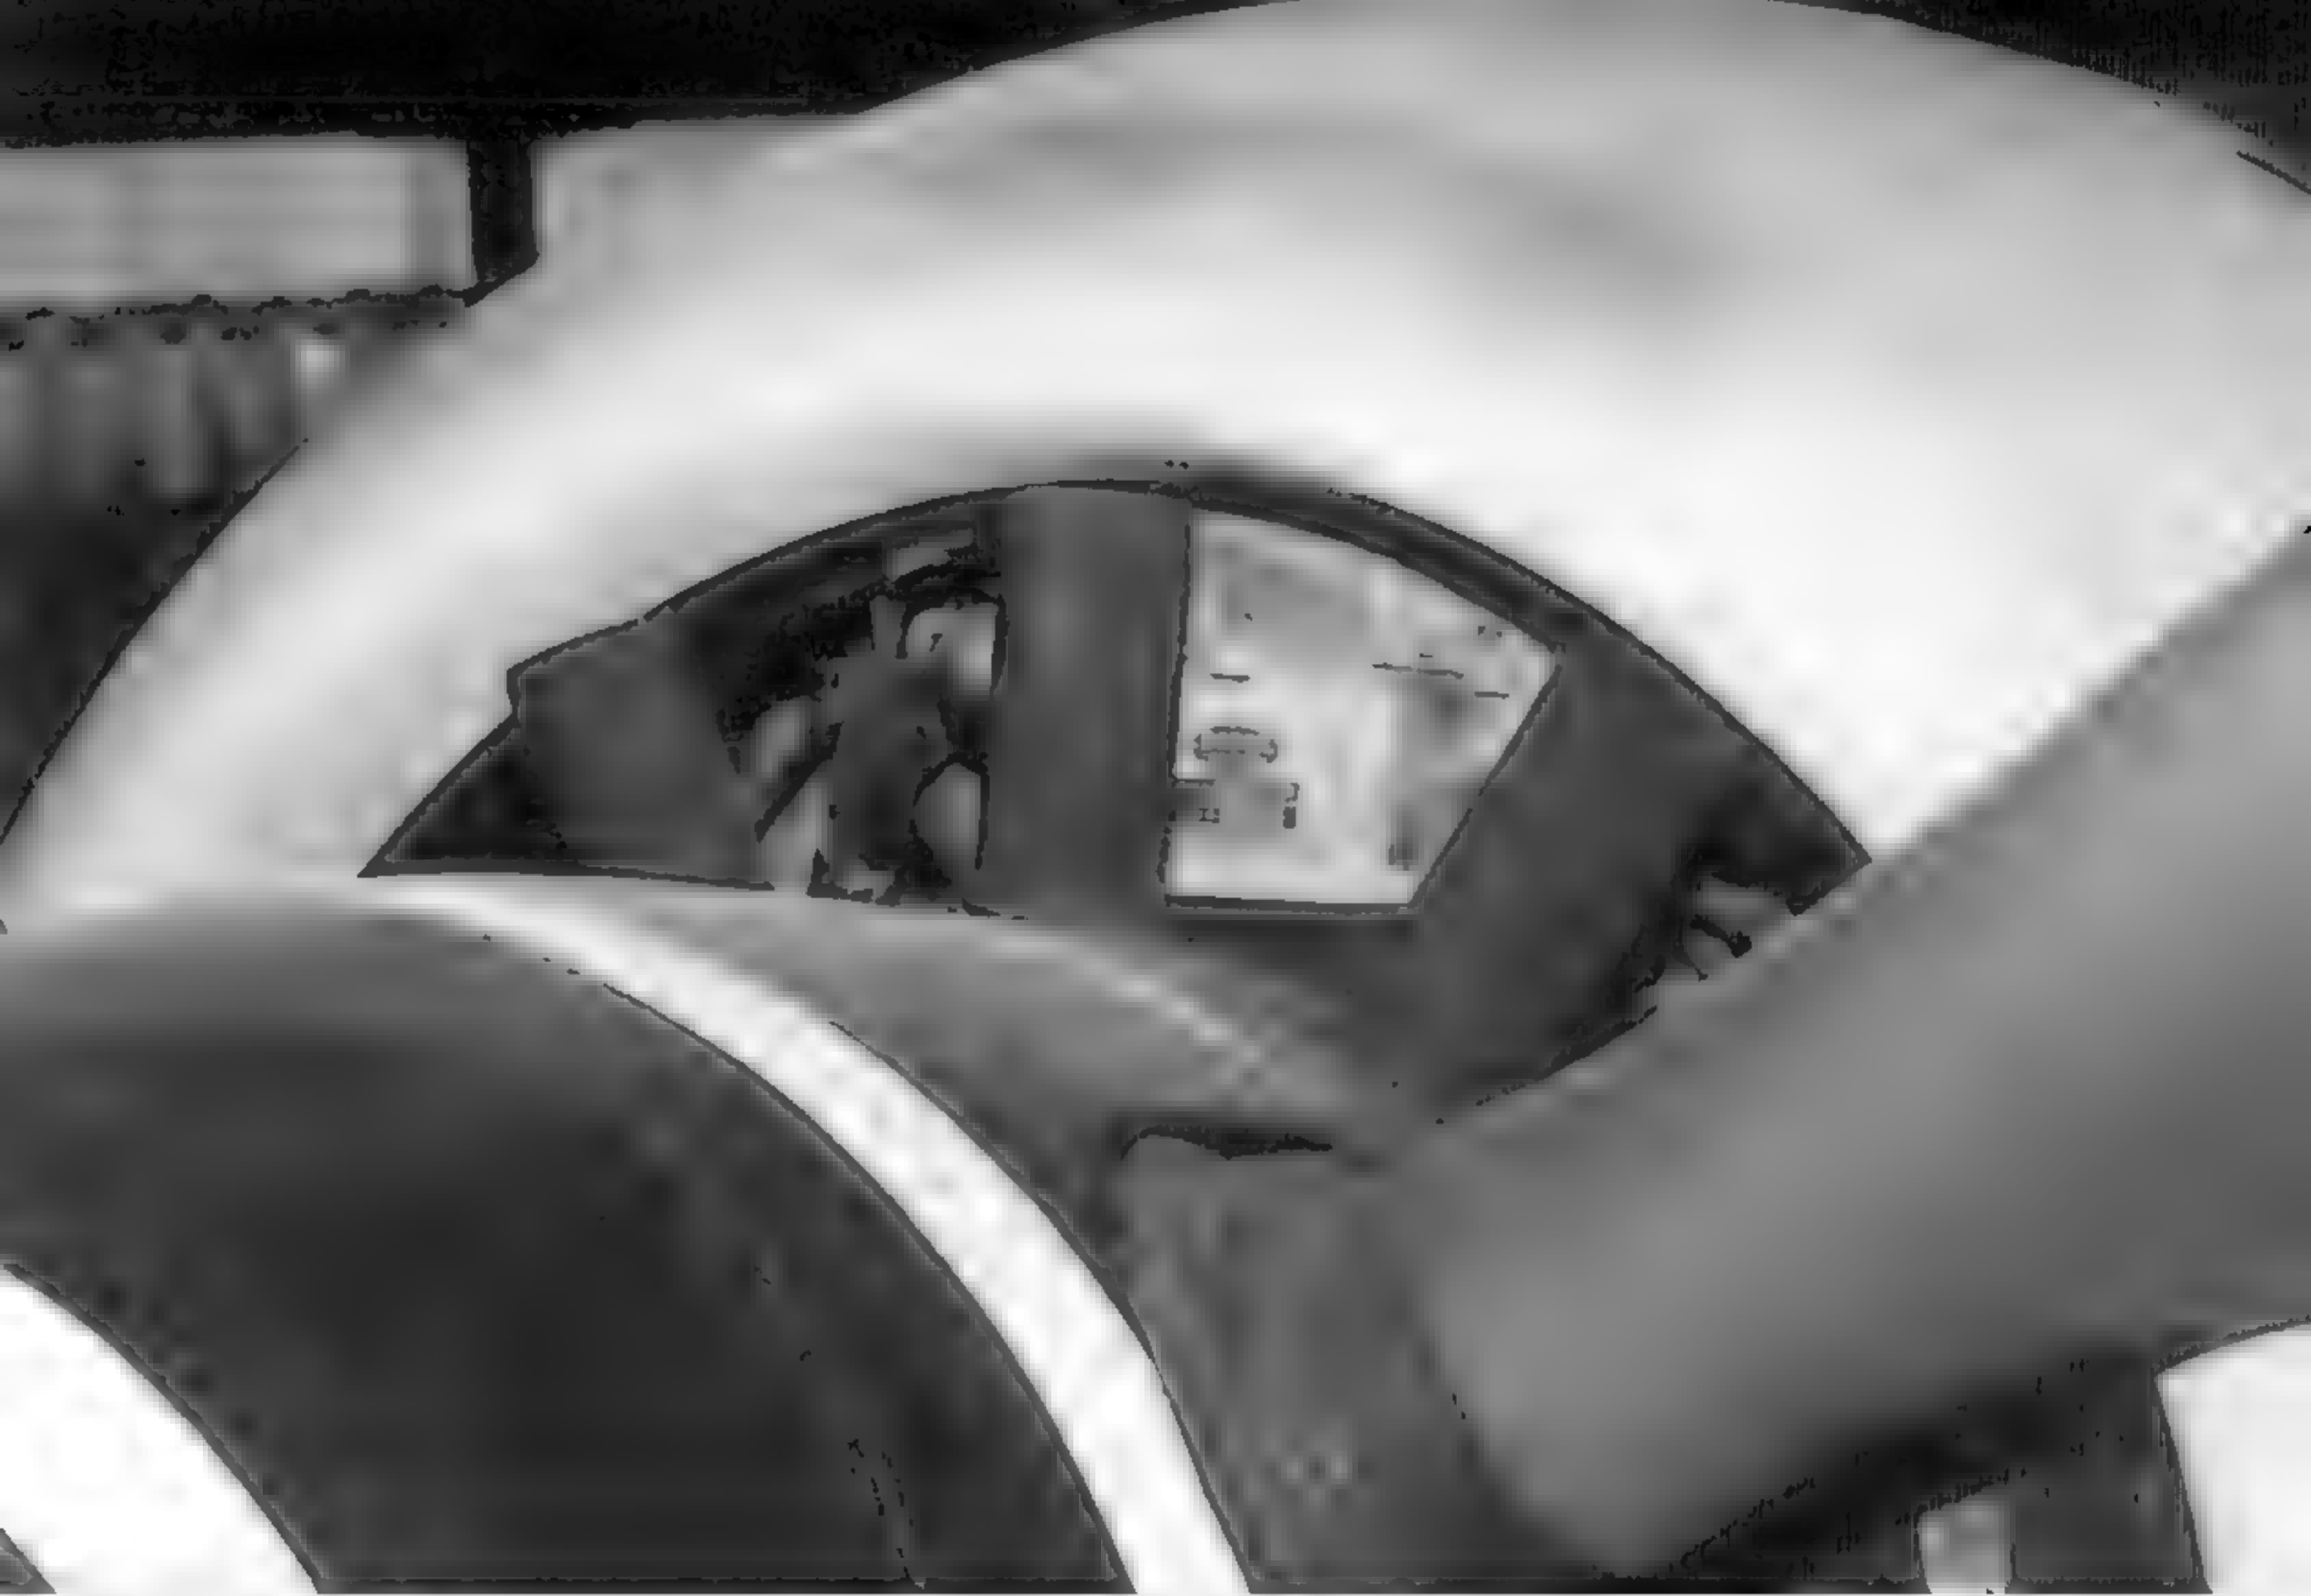
The Bosch magneto mounted at the top of the engine – just behind the engine cooling fan – served as the ignition source for the BMW 801D-2 engine. The *Kommandogerat* (control unit) mounted on the port side of the engine front provided automatic control for the engine. This unit allowed the pilot to operate the Fw 190A with only one throttle lever. (Molnar & Hugo)

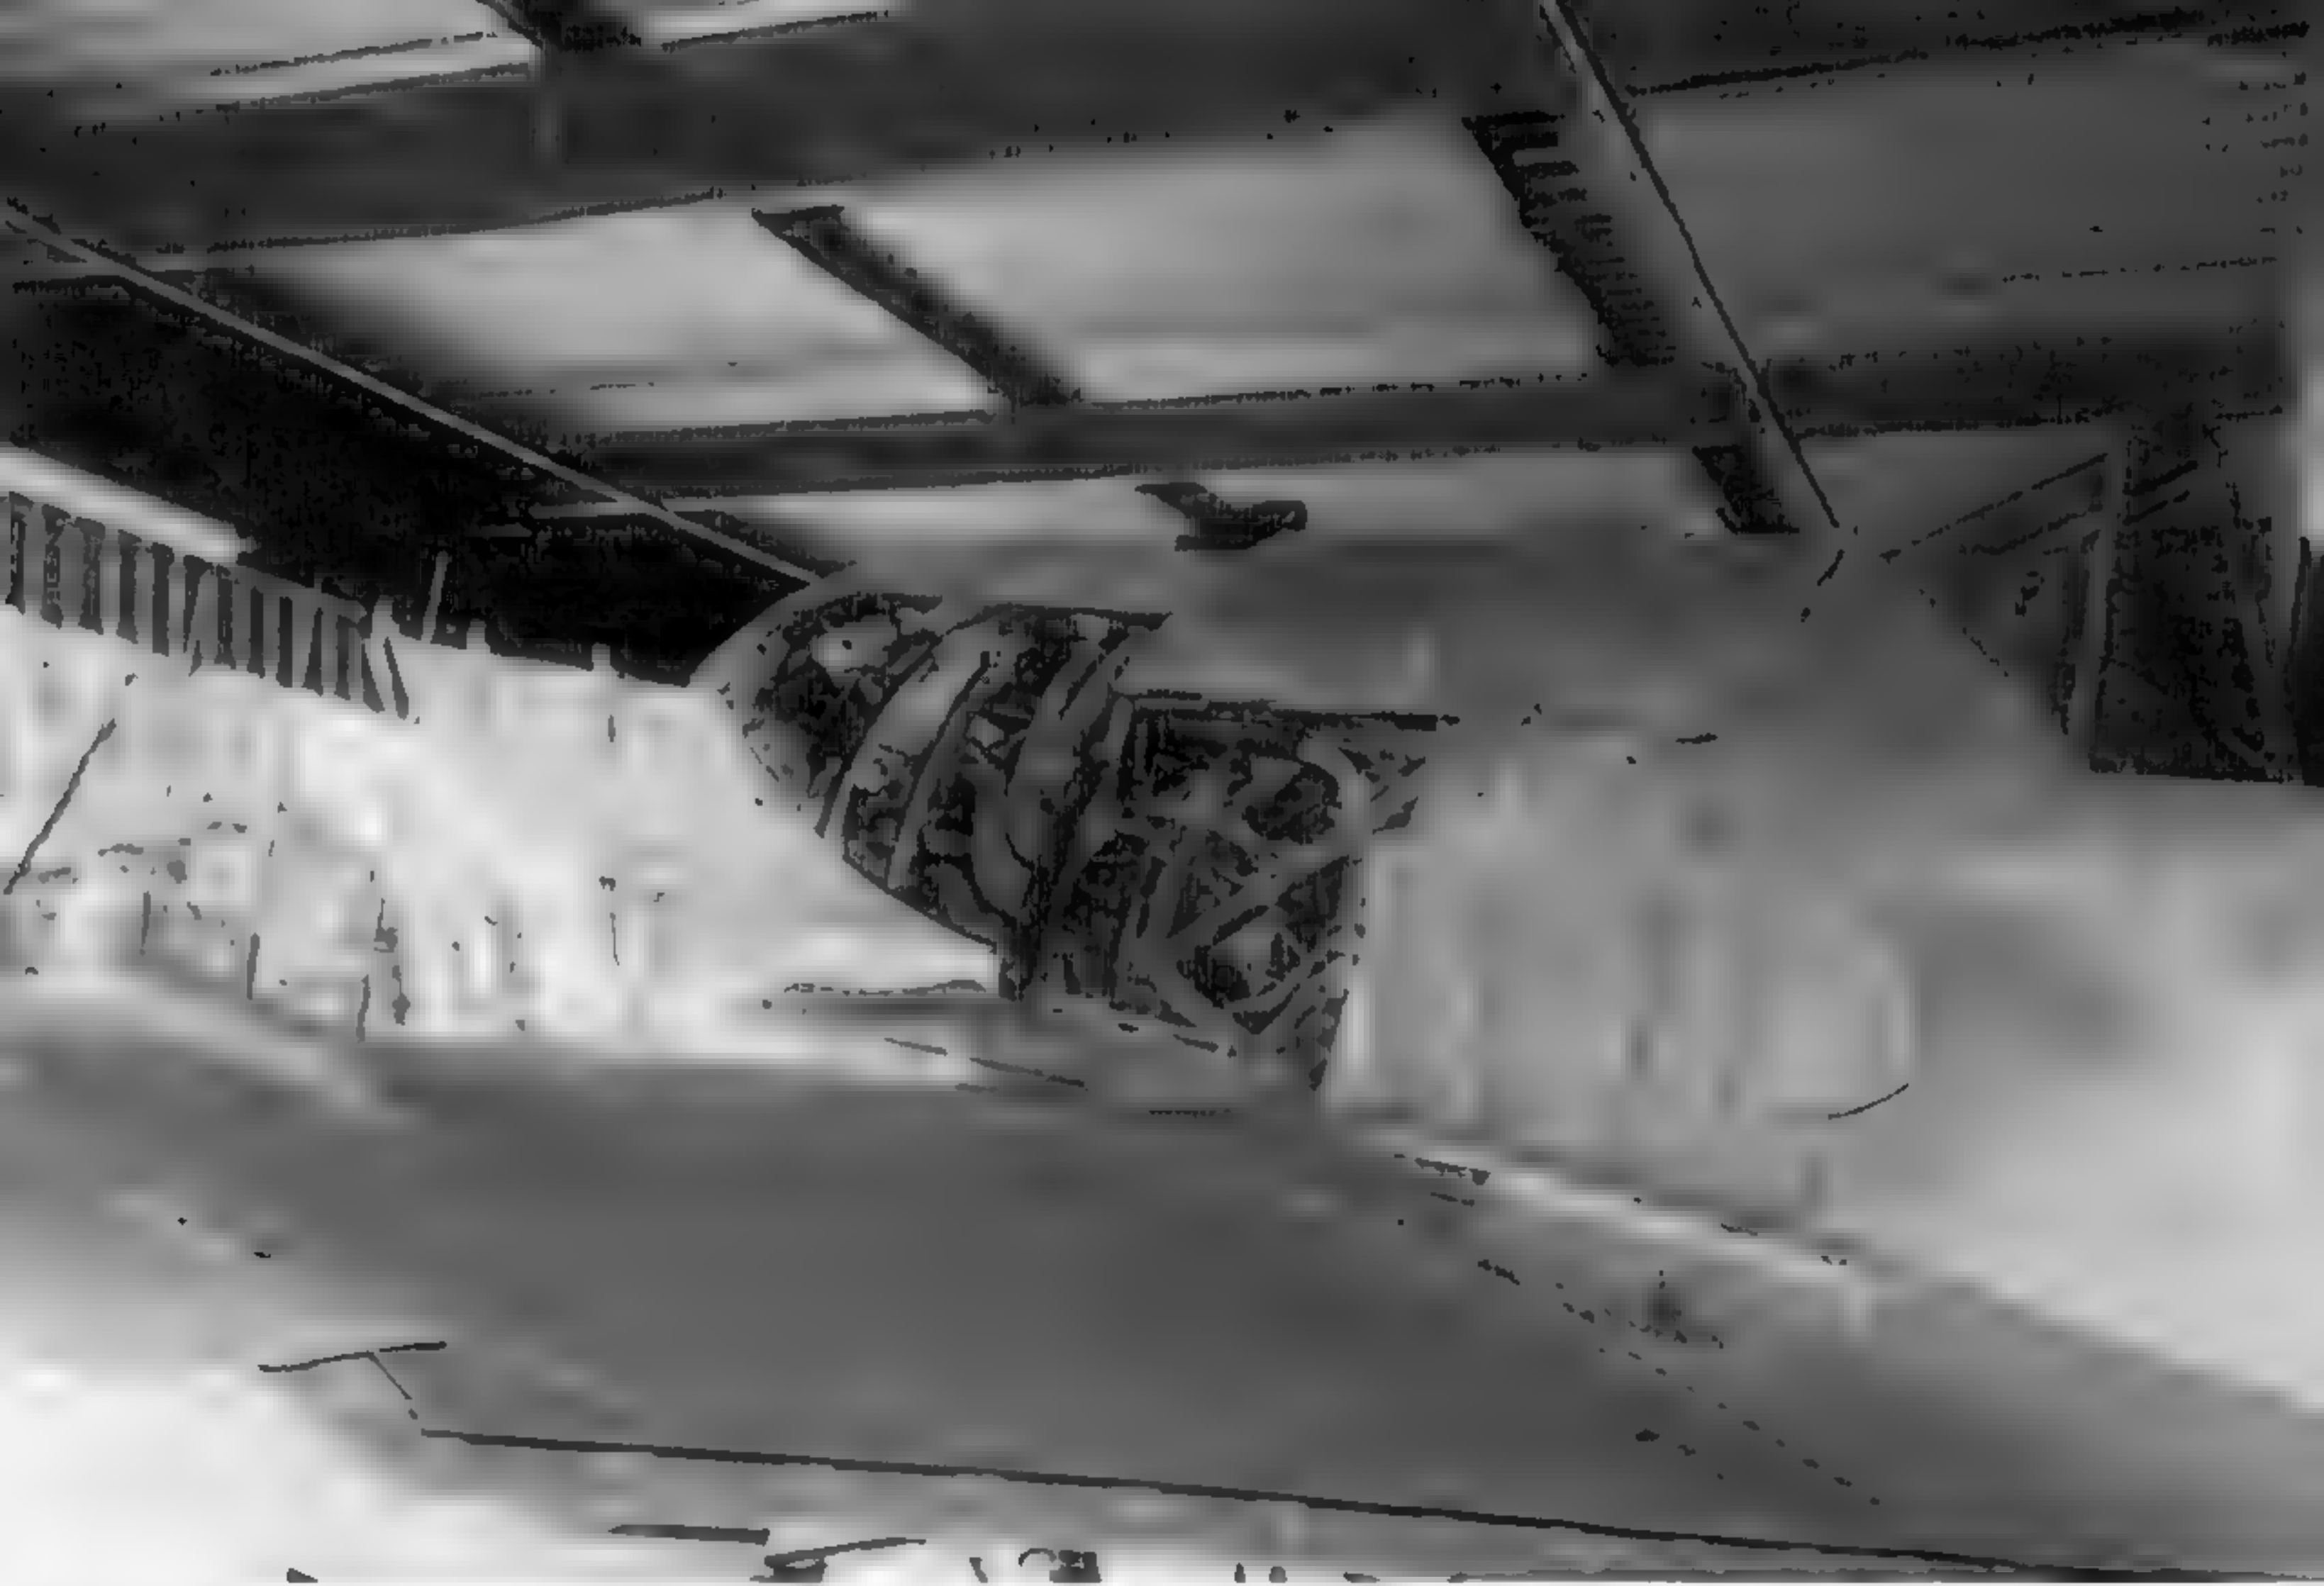
**(Above) The port engine cowling and wing-root 20mm gun bay doors opened for access to these areas of the Fw 190A-6. The Z-shaped part in the accessory section behind the engine is part of the engine bearer assembly, which connected the engine-mounting ring to the fuselage. The door interiors are painted RLM 02 Gray. The gun bay cover included interior bracing and mounts for seven latches. (Molnar & Hugo)**
